# **NASA Goddard Space Flight Center**

## **SONY Li Ion 18650HC Cell PTC, CID, Operation in a Very Large-Scale Parallel String Configuration**

NASA Space Battery Workshop

Nov 15 – 17, 2011

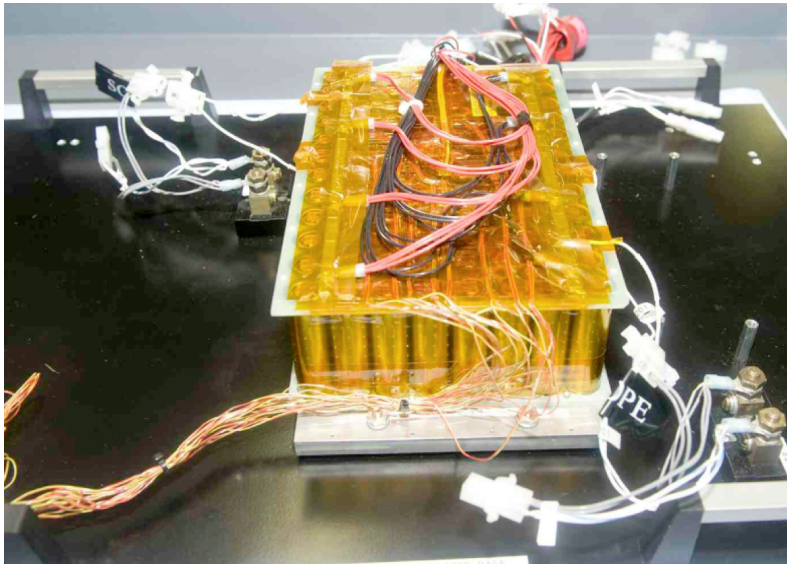
Un-blanketed

- The tests consisted of shorting the 2 cells one at a time and documenting the temperature, voltage, and current responses.
- The pack was set up thermally in as flight like configuration as possible mounted on a base plate with mounting brackets and Cho-Therm as the flight unit would be mounted. In addition the pack was blanketed to mitigate any convective effects.

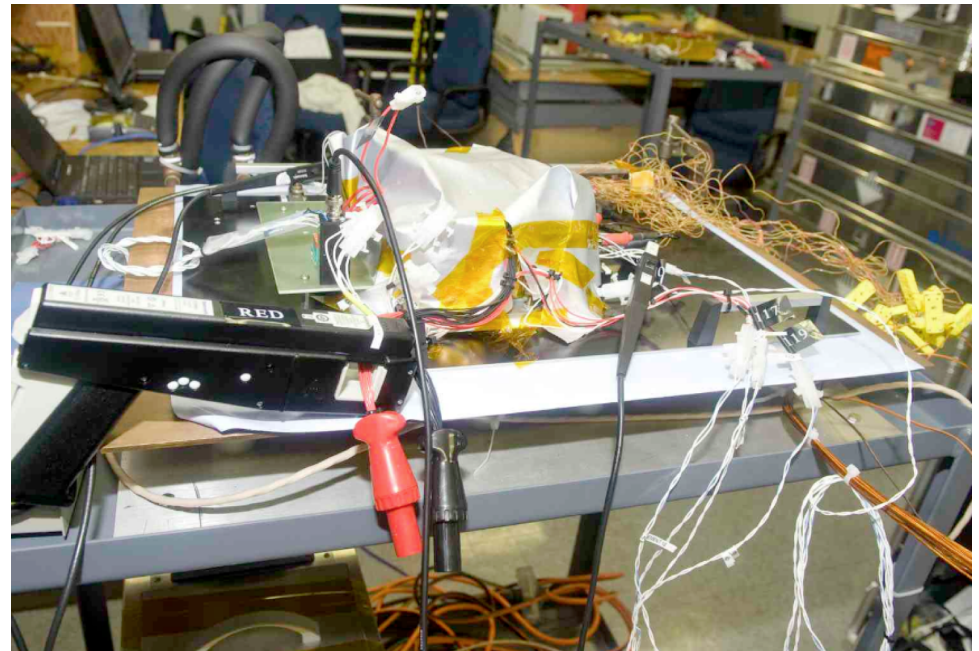
Blanketed and Instrumented

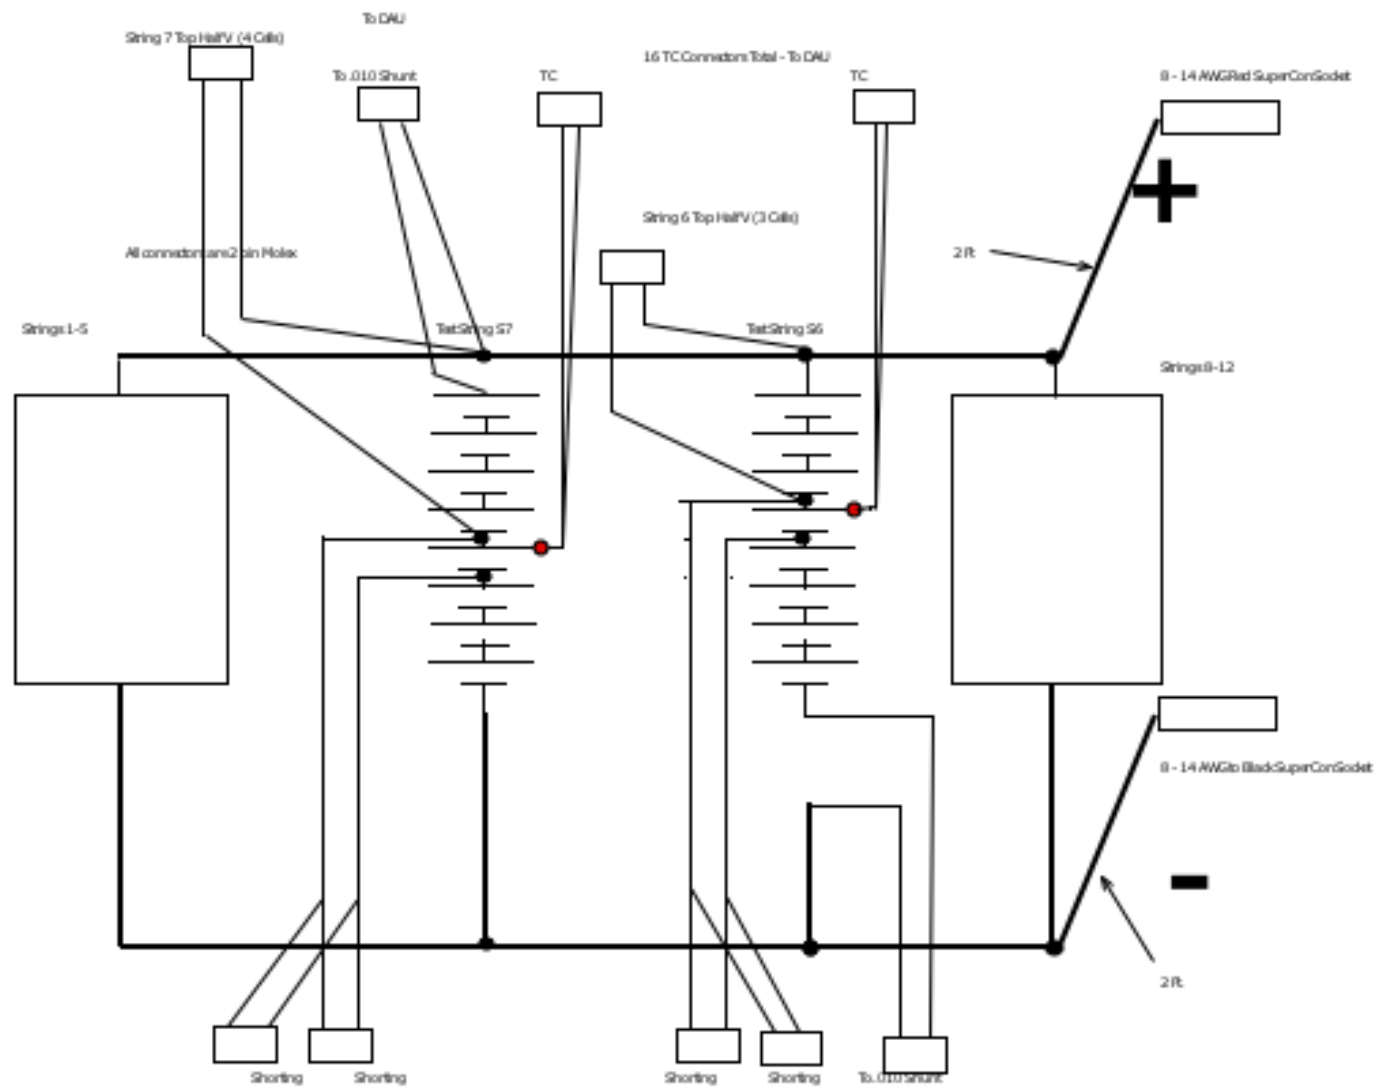
# Pack Connector Wiring

- Telemetry from the test pack included 16 thermocouples, voltage across the top 3 cells of string #6 and the top 4 cells of string #7, current through each shorted cell, current through string #6, current through string #7 and overall pack voltage.

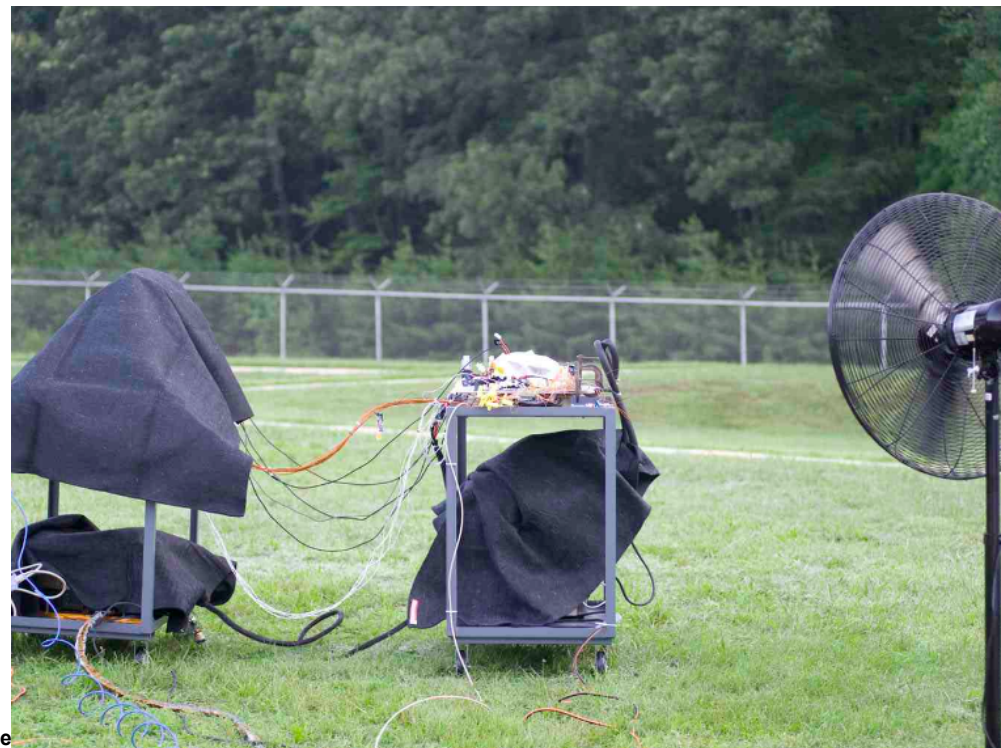
Test Pack  
“Out Standing  
In its Field”

- Creating the shorts and the attending cell over voltage in the test pack would cause heating and possibly a fire.
- Precautions related to these safety concerns resulted in locating the test outdoors and included protective clothing and readily available fire extinguishers.

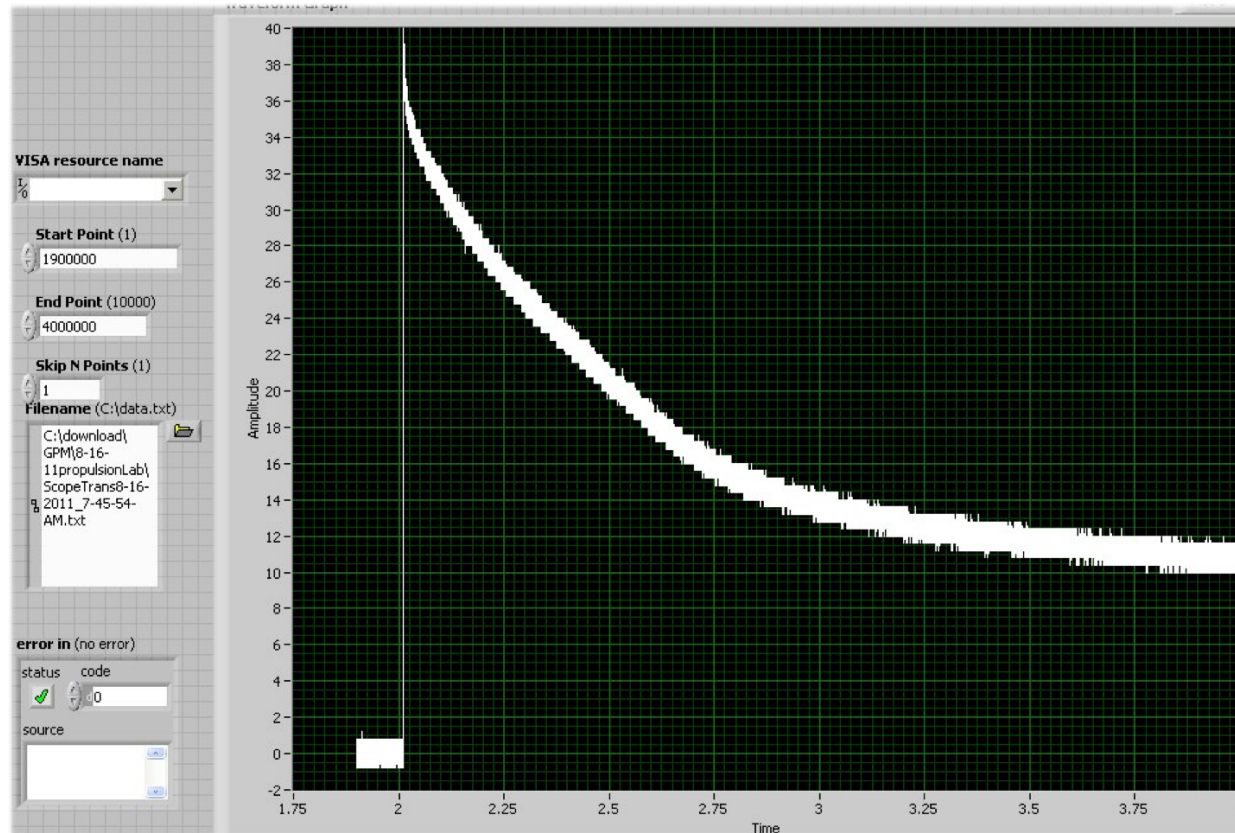
# S6C4 Shorting Current Results

This is a data capture of the transient through S6C4 after the 0745 EST short was commanded. The time scale is 2 sec. The cell internal PTC device actuated quickly to reduce the current from 40 to 10 A.

- In this test the 18650HC cells internal PTC/CID features responded as designed. The short across a cell resulted in large instantaneous currents in that cell that tapered within 2 seconds due to the action of that cells internal PTC feature.

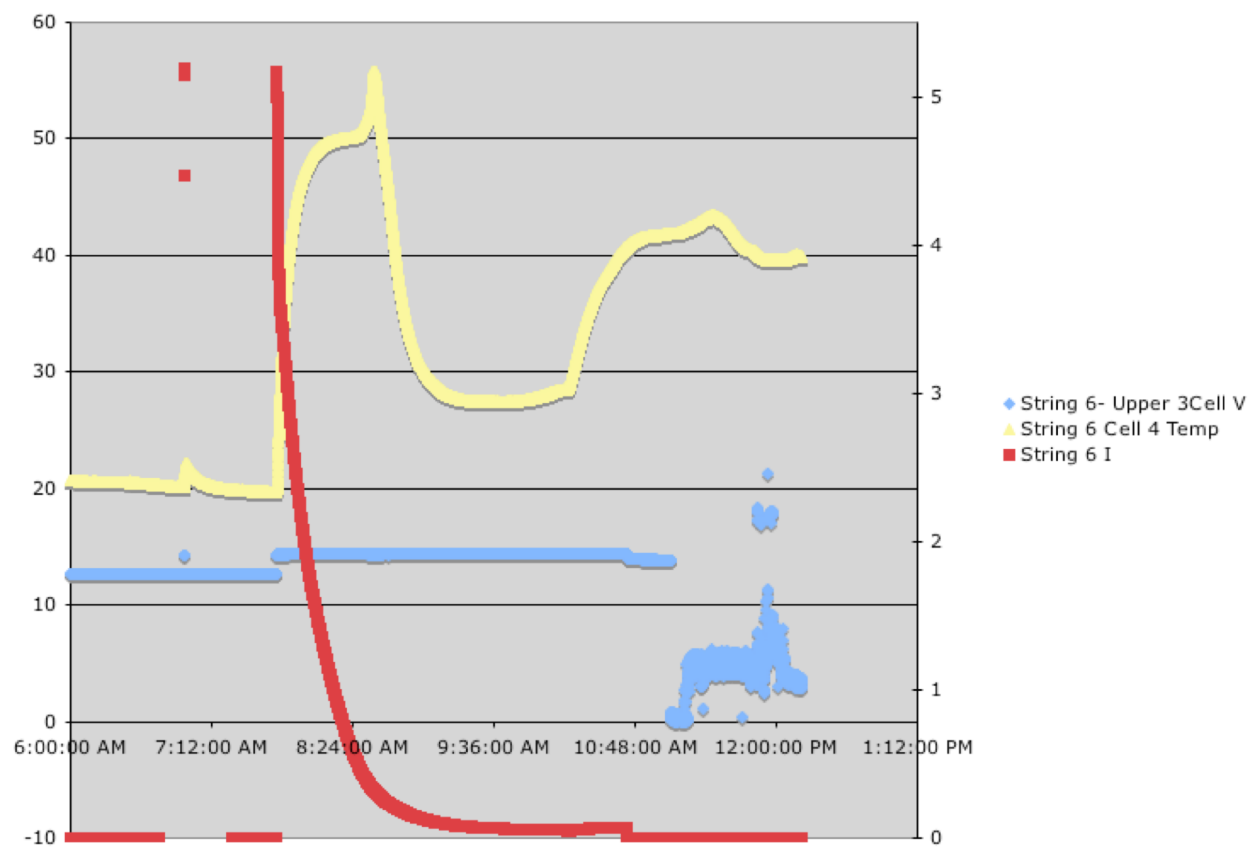
# String 6 Telemetry

The data shows that the current through the shorted string continued to decrease for about 3 hrs. to about 70 mA and then abruptly went to 0A at 1044 EST. This indicated one or more of the string's Current Interrupt Devices (CIDs) had opened up electrically isolating the string from the rest of the pack. (Note that the temperature rise after 1044 EST above was due to the adjacent S7C5 being shorted at 1013 EST)

- The #6 string current tapered to 70 mA and the string finally opened approximately 3 hours after the cell #4 shorting event.
- The #7 string current tapered to 170 mA and the string finally opened approximately 1.25 hours after the cell #5 shorting event.
- The temperature rise of the shorted cells and throughout the pack was moderate with a max peak of 65 C being recorded on the shorted cells, well below the thermal runaway point.
- No smoke, electrolyte leakage, or any other physical pack damage was noted.

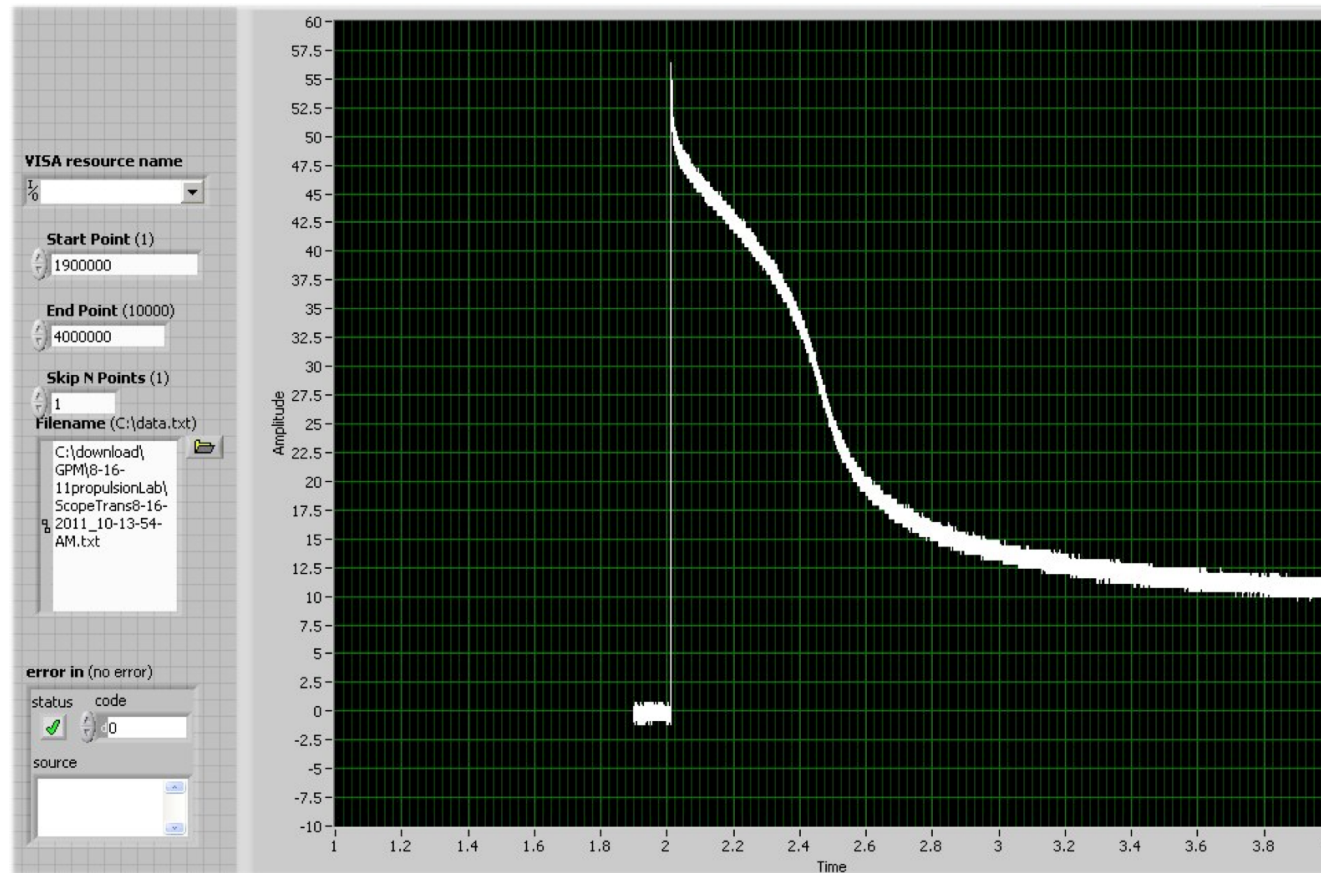
# S7C5 Shorting Current Results

This is a data capture of the transient through S7C5 after the 1013 EST short was commanded. The time scale is 2 sec. The cell internal PTC device actuated quickly to reduce the current from 55 to 10 A.

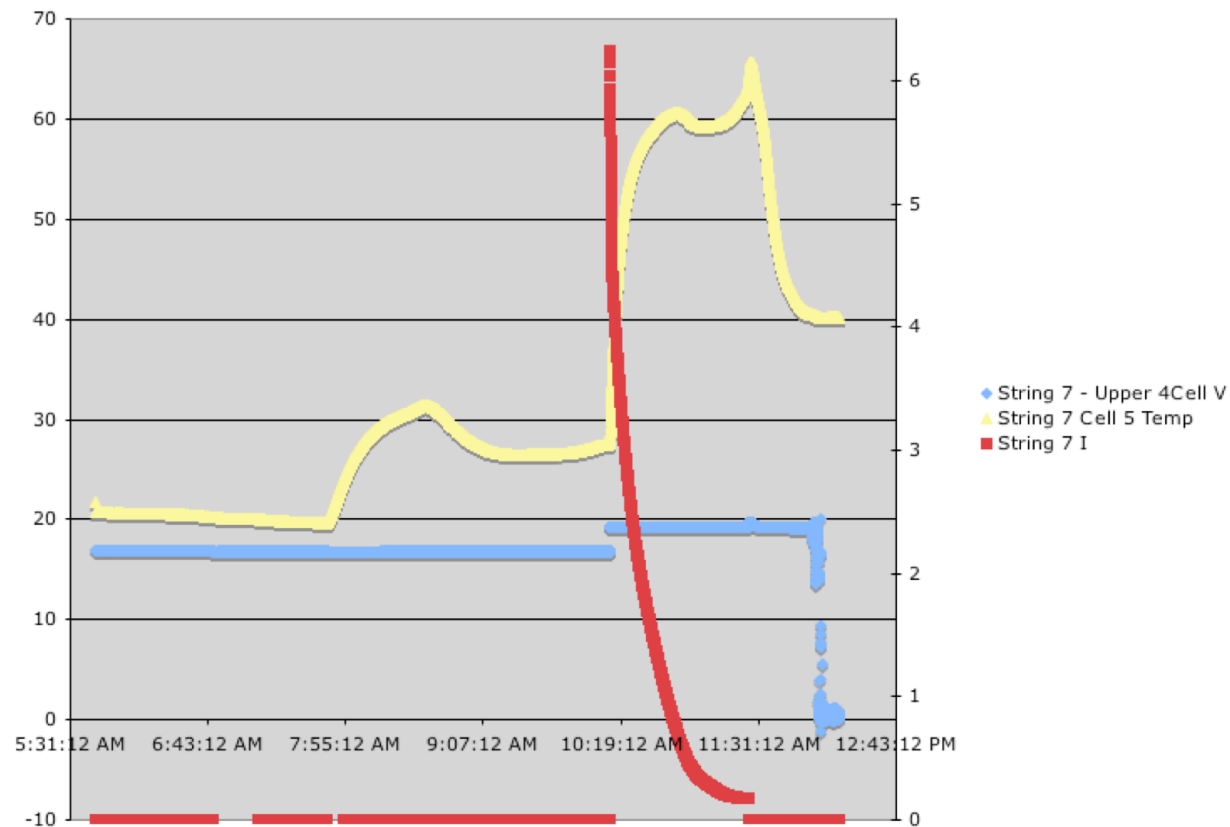
# String 7 Telemetry

The data shows that the current through the shorted string continued to decrease for about 1.25 hrs. to about 170 mA and then abruptly went to 0A at 1125 EST. This indicated one or more of the strings Current Interrupt Devices (CIDs) had opened up electrically isolating the string from the rest of the pack.

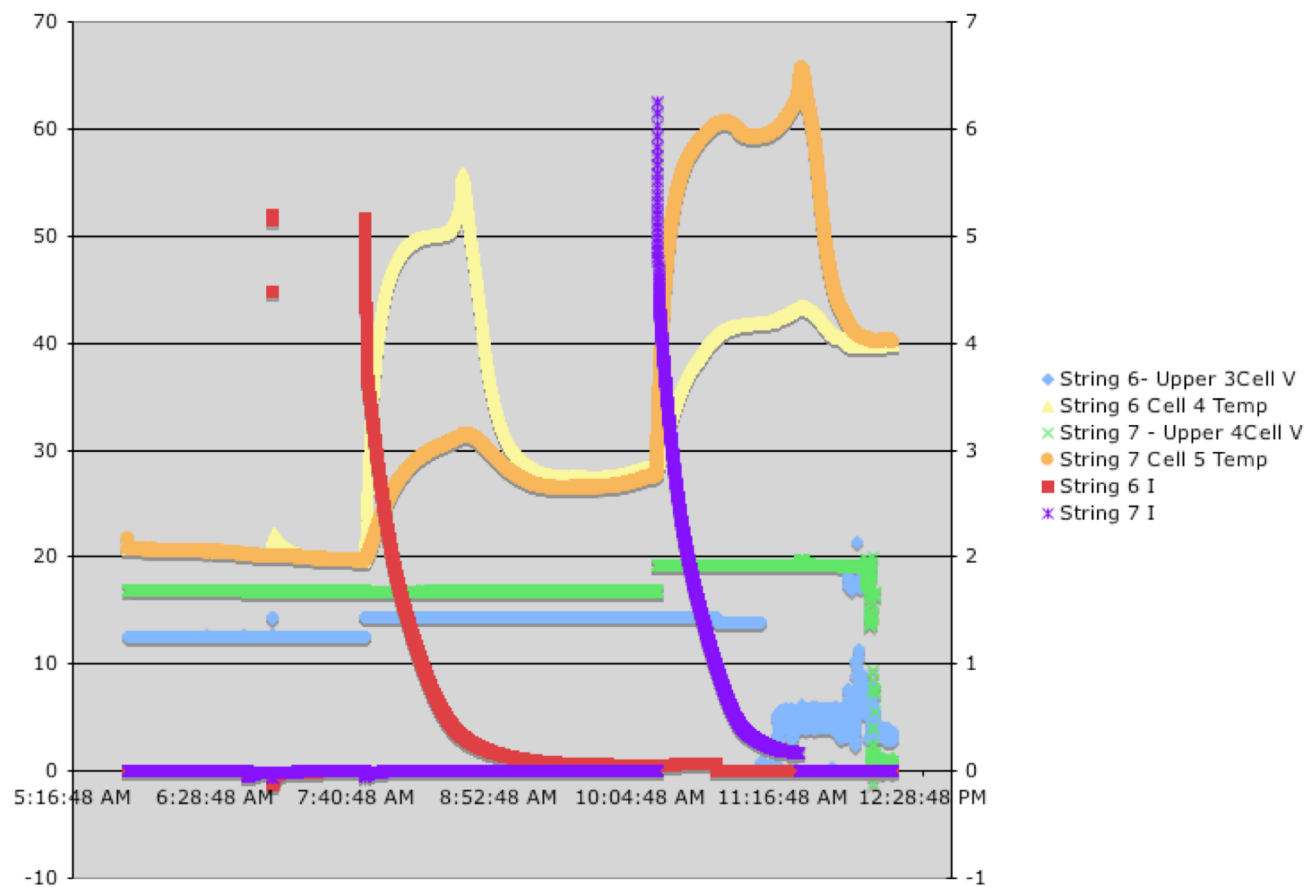
# String 6 and 7 Telemetry

Combined S6, S7 trend data

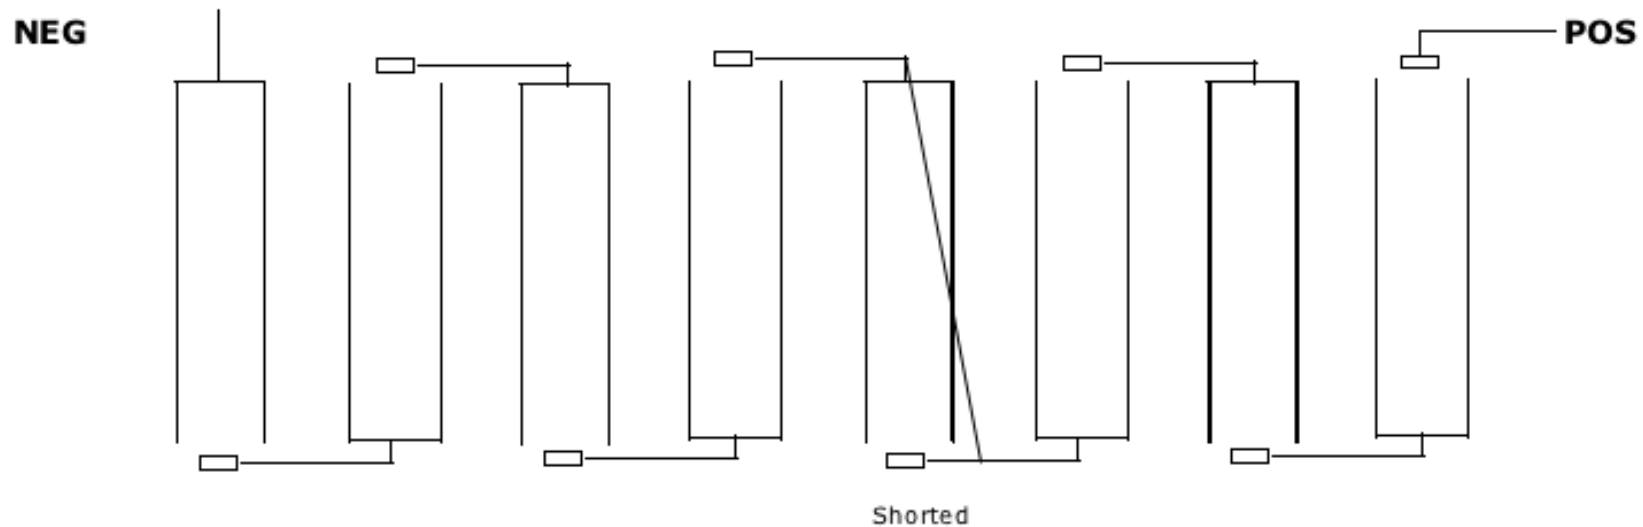
# String 6 Post Test Cell Voltages

Cell 8	Cell 7	Cell 6	Cell 5	Cell 4	Cell 3	Cell 2	Cell 1	
8/17/11	.000V	.000V	.000V	.050V	.000V	.200V	.093V	.400V	
8/23/11	2.7V *	0.031V	2.9V*	0.041V	.000V	.4V*	.2V*	3.0V*	* Decaying voltages
9/7/11	3.3V *	0.020V	2.8V*	0.023V	.000V	.4V*	.3V*	1.6V*	* Decaying voltages

- Post-test measurements indicate
  - String #6
    - Cell #4 still shorted with external shorting plug
    - Other 7 cells indicated an open circuit meaning 7 individual CIDs had activated
  - String #7
    - Cell #5 still shorted with external shorting plug
    - Cell #8 at 4.5V indicating its CID did not activate
    - Other 6 cells indicated an open circuit meaning 6 individual CIDs had activated

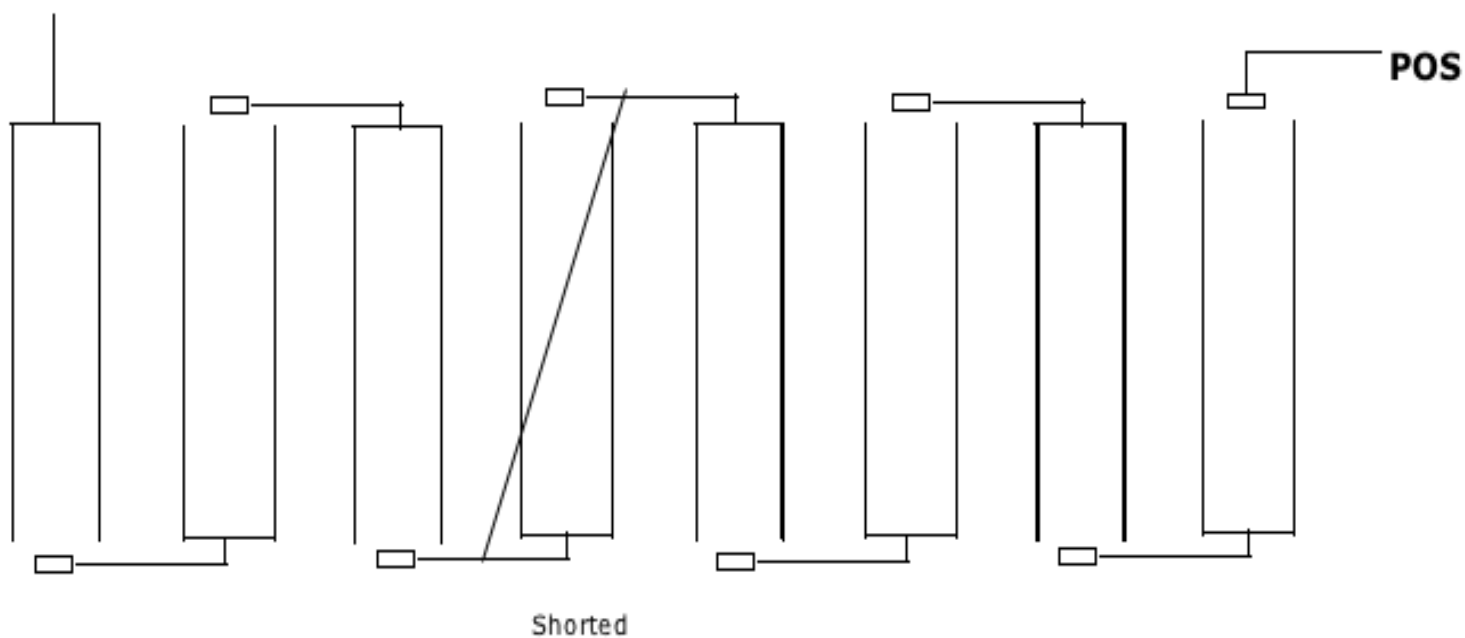
# String 7 Post Test Cell Voltages

Cell 8	Cell 7	Cell 6	Cell 5	Cell 4	Cell 3	Cell 2	Cell 1	
8/17/11	4.578V	.007V	1.4V	.000V	1.5V	1.6V	2.0V	.000V	
8/23/11	4.542V	0.01V	2.8V*	.000V	2.2V*	2.1V*	2.7V*	.006V	* Decaying voltages
9/7/11	4.49V	0.006V	3.2V*	0.000V	3.3V*	2.5V*	2.7V*	.008V*	* Decaying voltages

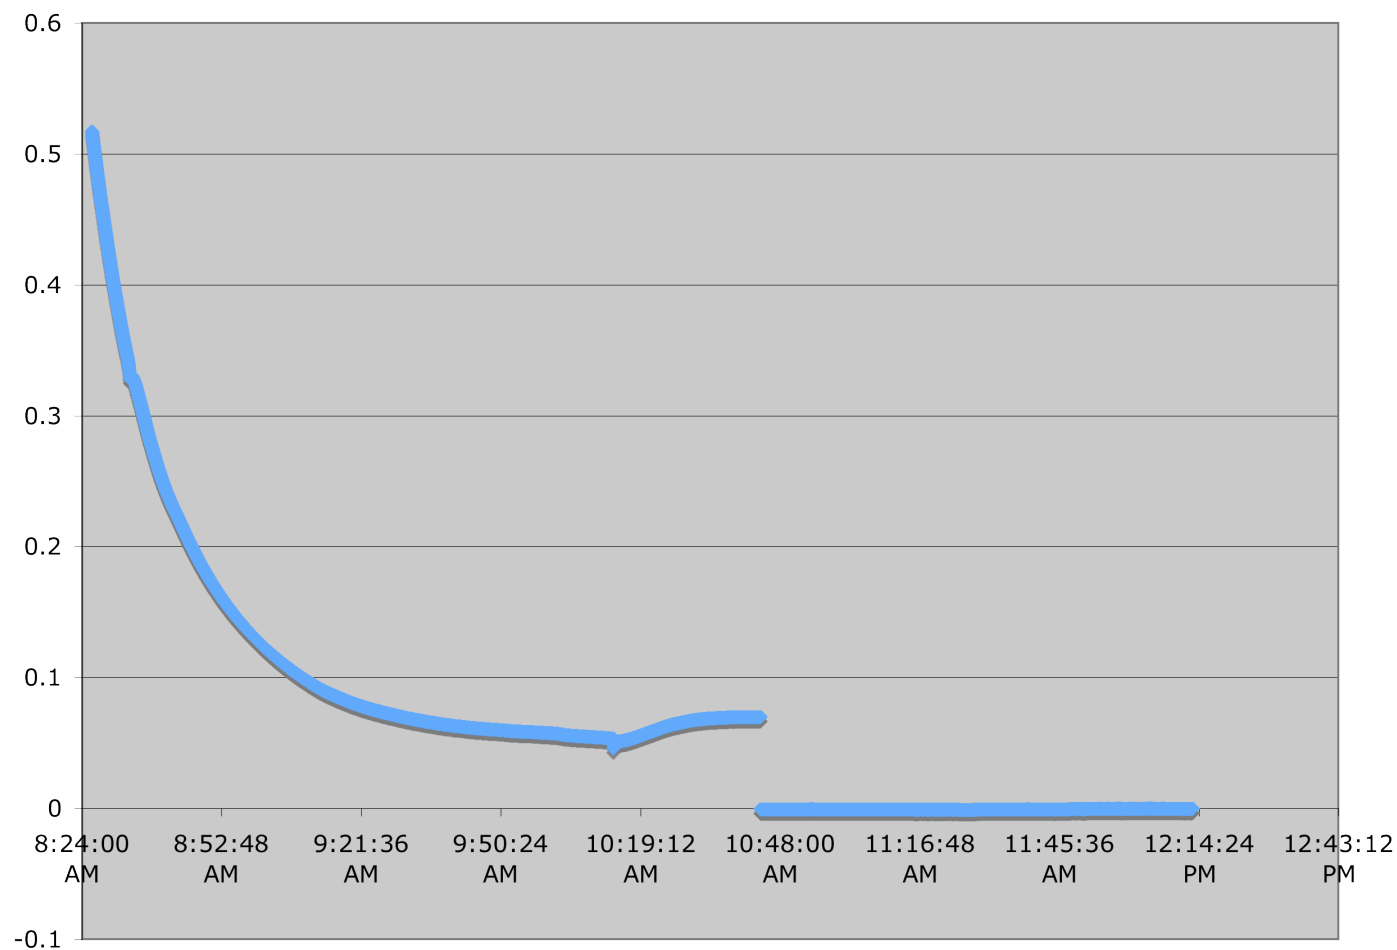
# String 6 Telemetry Detail

String6 I

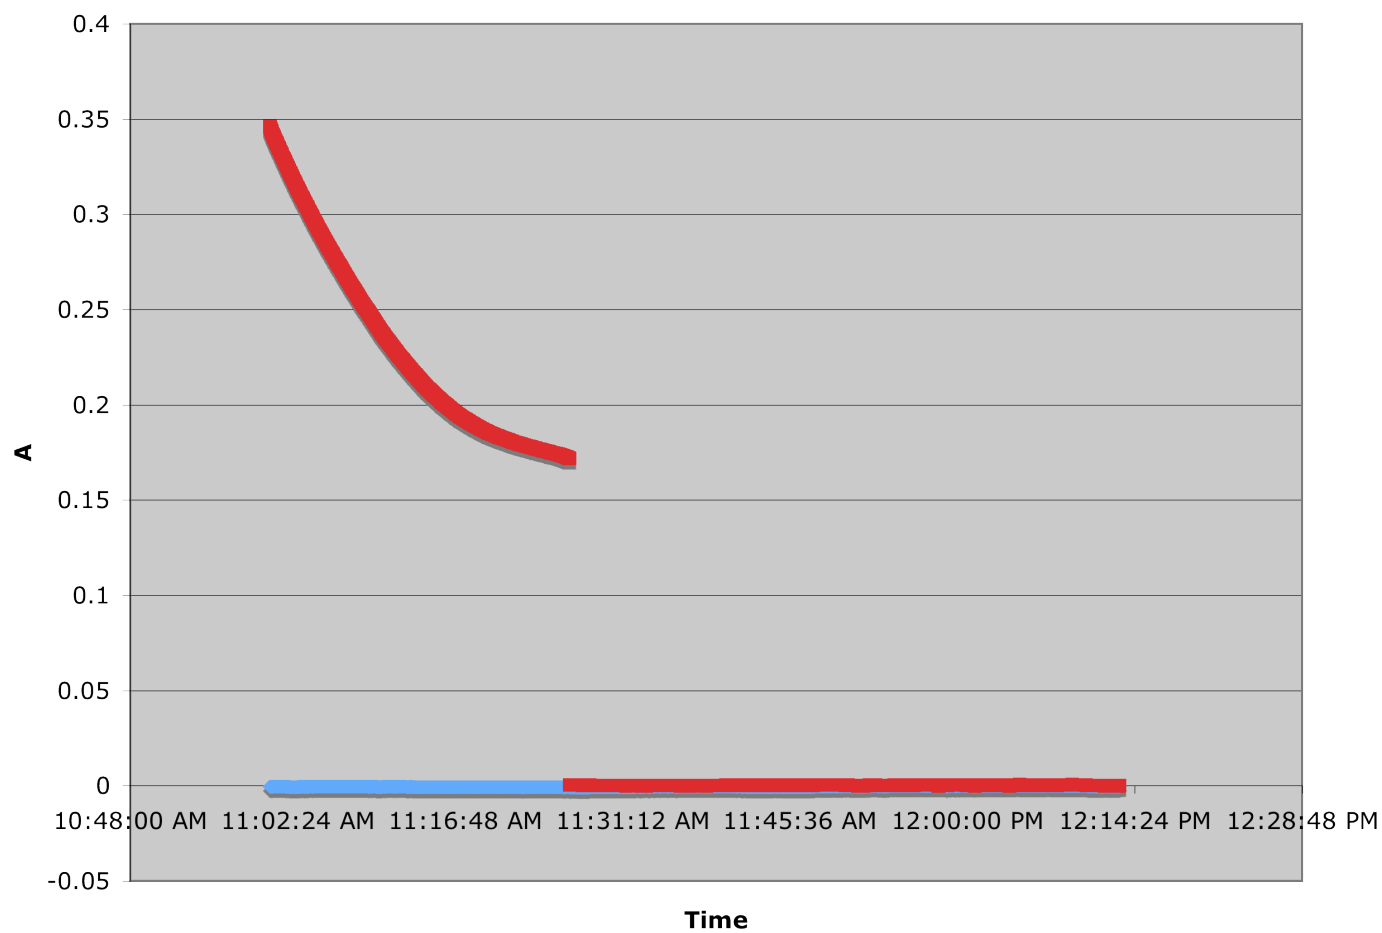
# String 7 Telemetry Detail

String 7 I Detail

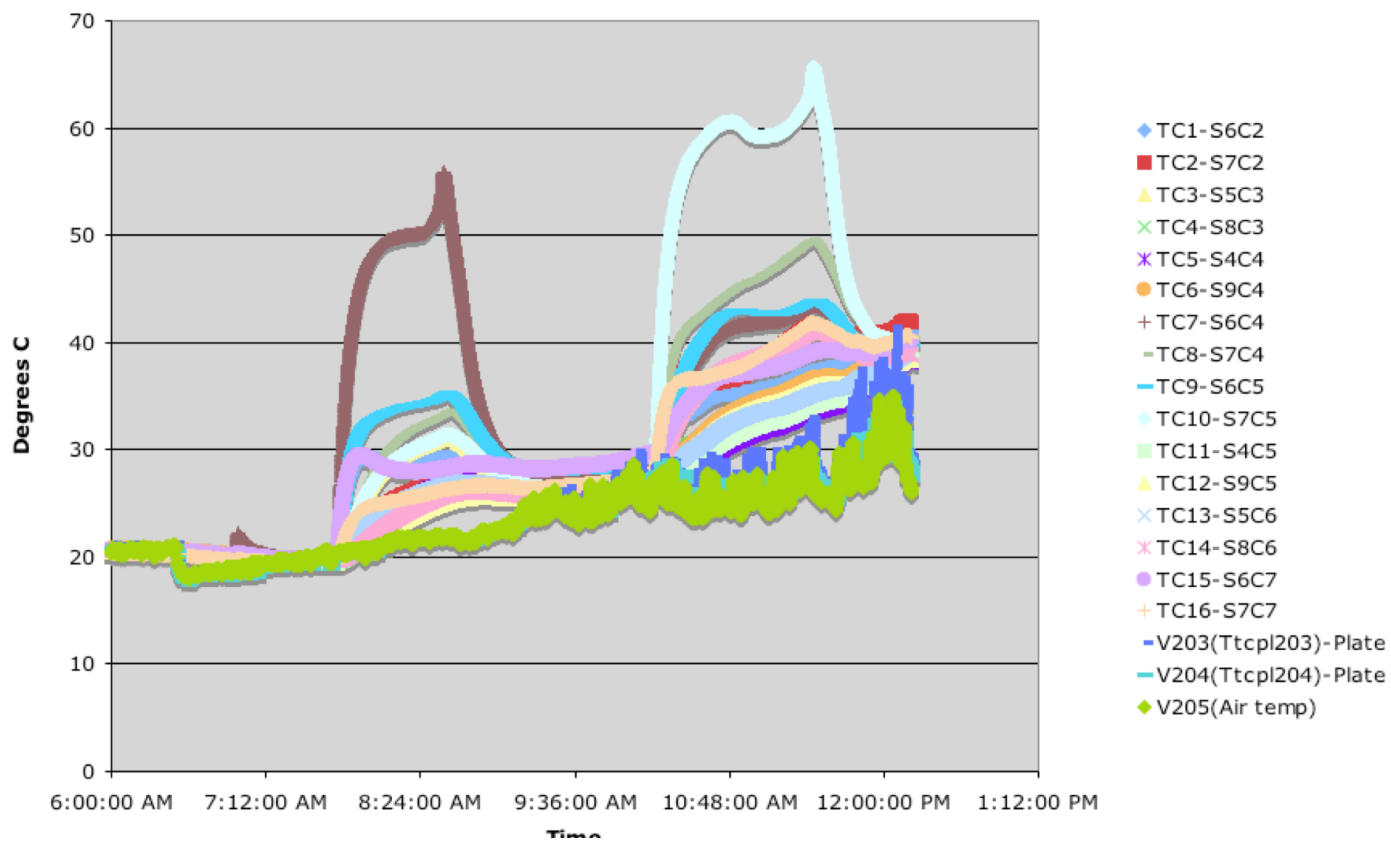
# All Temperature Telemetry

PTC/CID Pack SN002 Test Temps
